# **McKAY LOG HOUSE PHYSICAL CONDITION ASSESSMENT**

Besser Museum for Northeast Michigan  
Alpena, Michigan

Richard Neumann Architect  
21 May 2020

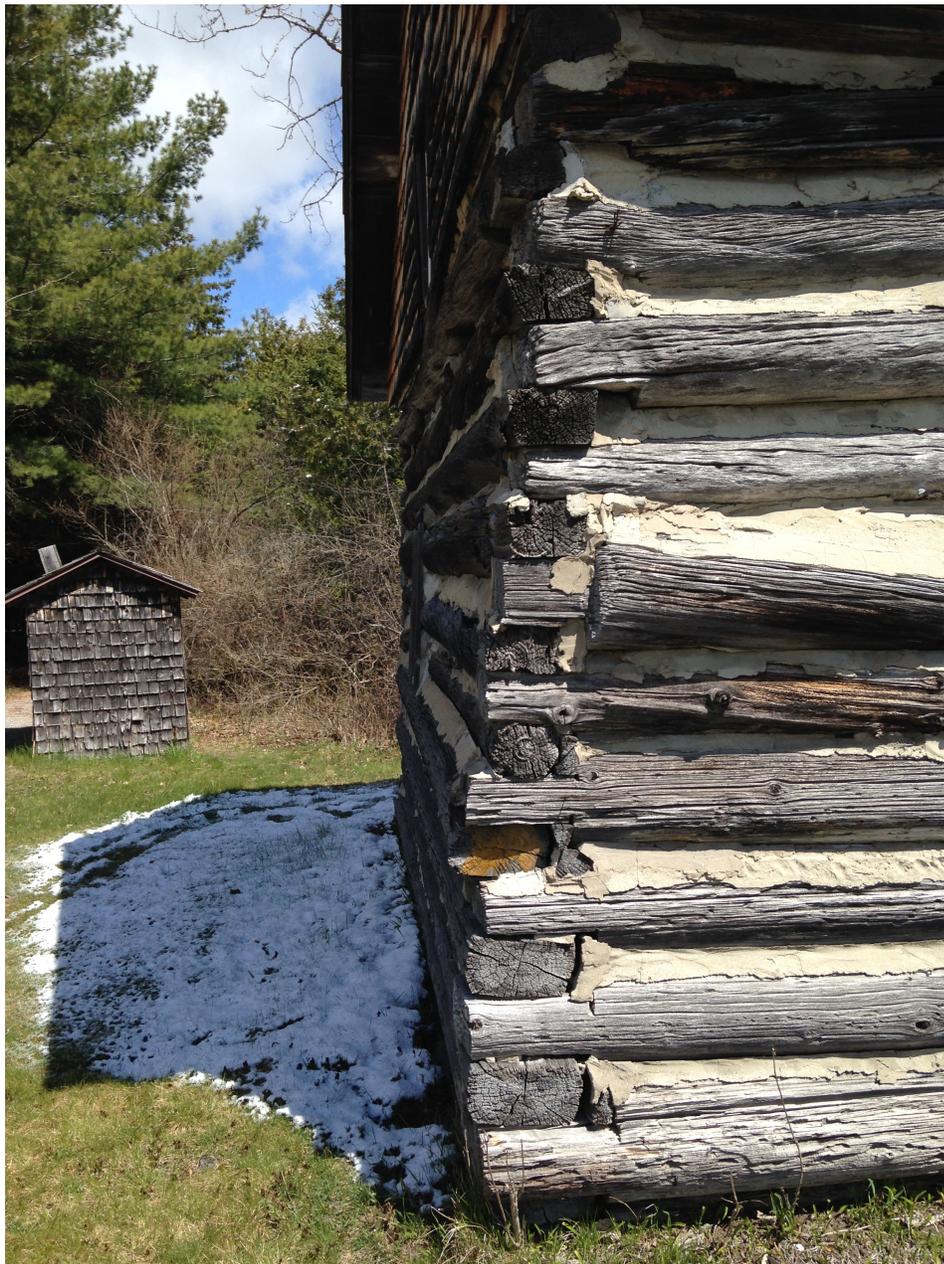
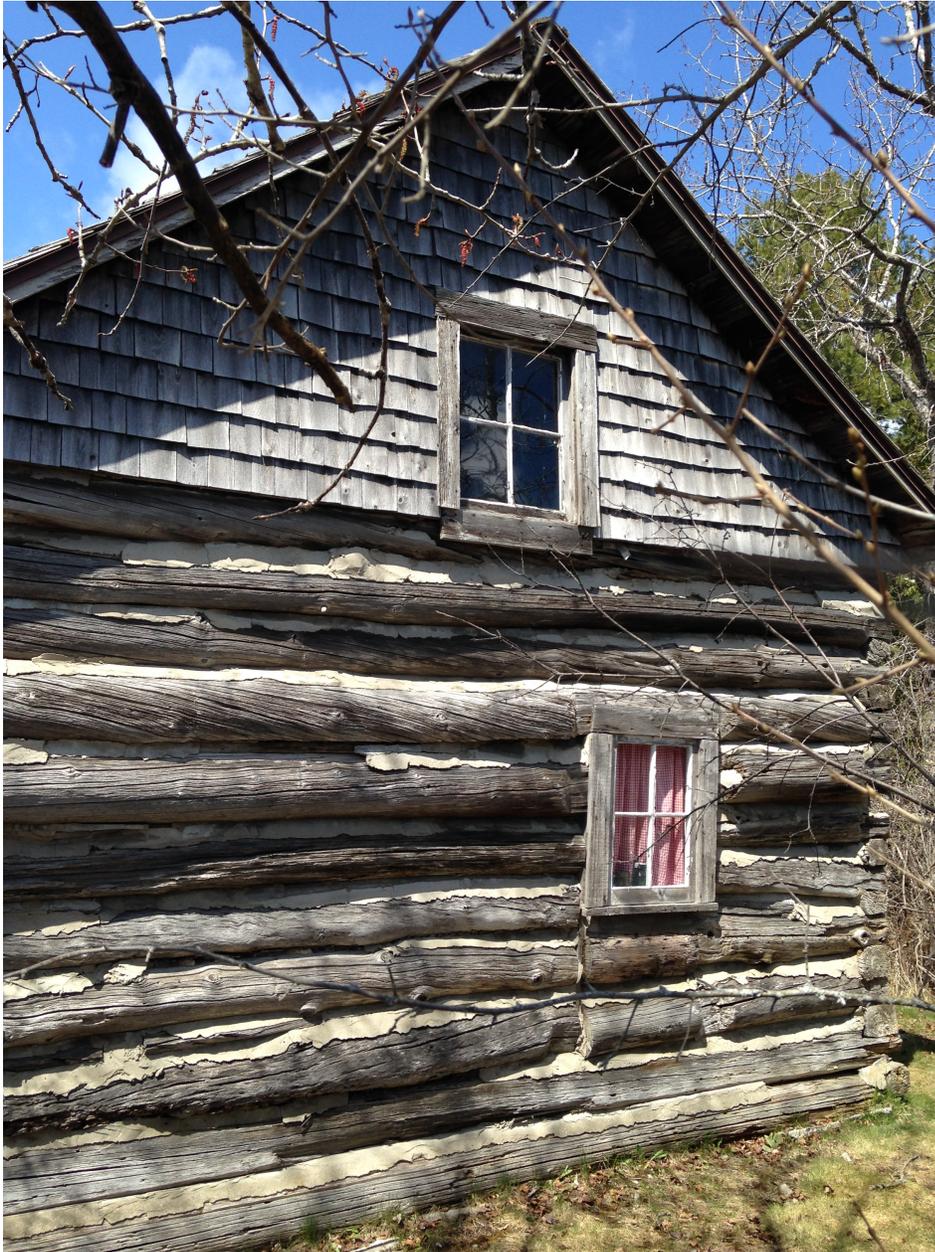
**Assessment:** Considering the wall logs are over 120 years old, are quite exposed to the weather due to their convex shape, and are of a red pine species, many still seem in good structural condition. Most are split and checked, allowing moisture to penetrate, but being a loosely constructed rudimentary structure, good air movement around and through the walls likely provides good drying of wet wood, preventing a continuously moist condition. At least two logs on each of the front, rear, and right end walls, plus the bottom two tiers of logs around the whole perimeter of the house are in quite bad condition. Several logs, including at the level of second floor joist bearing, have shifted outward probably due to failure of pin or nail connections at the corners. This has weakened joist bearing, and is of concern.

The condition of the mortar daubing varies a lot around the house. In many joints the mortar is solid and tightly bonded to the logs, but in others it is loose, and in many places has fallen out.

**Wall Logs** - It is now apparent that deterioration of the log wall structure is a growing issue that must be addressed. Many of the wall logs are at the end of their useful lives. But to minimize a wholesale replacement of the entire cabin, an effort should be made to retain as many existing historic logs as possible, and selectively replace only the most badly deteriorated ones.

These should include the four sill logs and probably the next course all the way around the house, and at least two others on each of the south (front), east, and north faces. Displaced logs at the level of second floor joist bearing should also be repaired or replaced. Likely some others will be found to be too extensively deteriorated to retain. Given the nature of log construction, often the surface of the timber seems solid, but rot has progressed in the center of the log, where it is harder to detect. So attempting to selectively replace just some logs will likely open a "can of worms", so to speak, and require replacement of others.

Once the scope of the log work is known, the scope of daubing replacement will be known. All may be required to be removed and replaced. Of course to be most authentic, mortar daubing should be used, but newer more high-performance acrylic daubing materials are now available, due to the popularity of log homes today. They provide better bonding to the logs, and the elasticity to flex with weather-related movement of the wood. These should be investigated and considered for use on the McKay House, if the appearance can duplicate the look of mortar daubing.
